# Final Bond Inspection

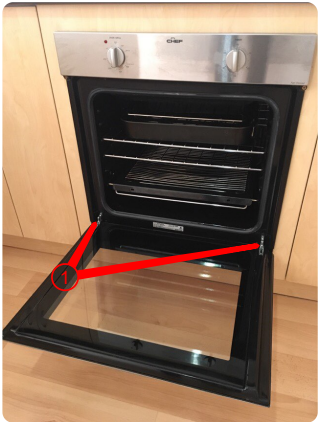
</div> <div>Current Photo: 1: Wear to hinges, door is slightly loose on oven</div>

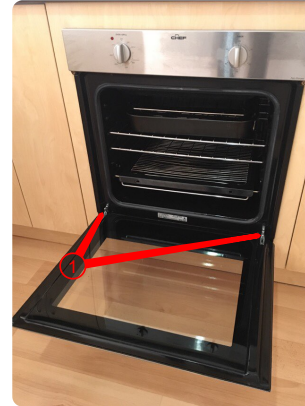
Image: 3

- 1: Wear to hinges, door is slightly loose on oven
