# Final Bond Inspection

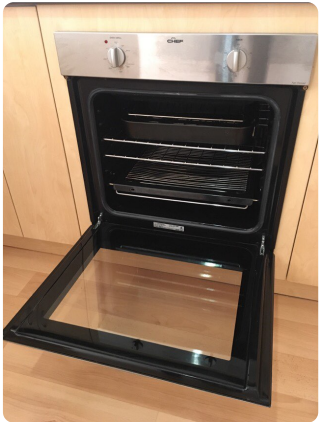
</div> <div>Current Photo:</div>	
<div><div>Y</div><div>N</div></div>		<div><div>Y</div><div>N</div></div>	
Oven			
Stainless steel fan forced oven, CHEF, with silver handle and glass faced door, 2 chrome racks, 1 black grill tray with chrome rack and 1 roasting tray with chrome rack, no obvious marks and in good working order.		<div>Loose oven door may require maintenance.</div> <div>Stainless steel fan forced oven, CHEF, with silver handle and glass faced door, 2 chrome racks, 1 black grill tray with chrome rack and 1 roasting tray with chrome rack, no obvious marks and in good working order.</div>	
<div>

</div> <div>Current Photo: 1: Wear to hinges, door is slightly loose on oven</div>

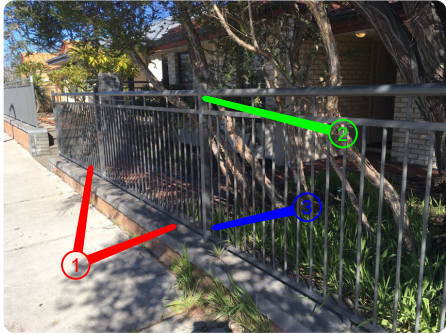
Image: 1

- 1: If any damage or wear has been incurred
- 2: We would be able to note it here
- 3: And make direct photo comparisons
